SLOPE STABILITY AND GEOLOGY
OF THE BALDWIN HILLS,
LOS ANGELES COUNTY, CALIFORNIA

1982

CALIFORNIA DEPARTMENT OF CONSERVATION
DIVISION OF MINES AND GEOLOGY

SPECIAL REPORT 152

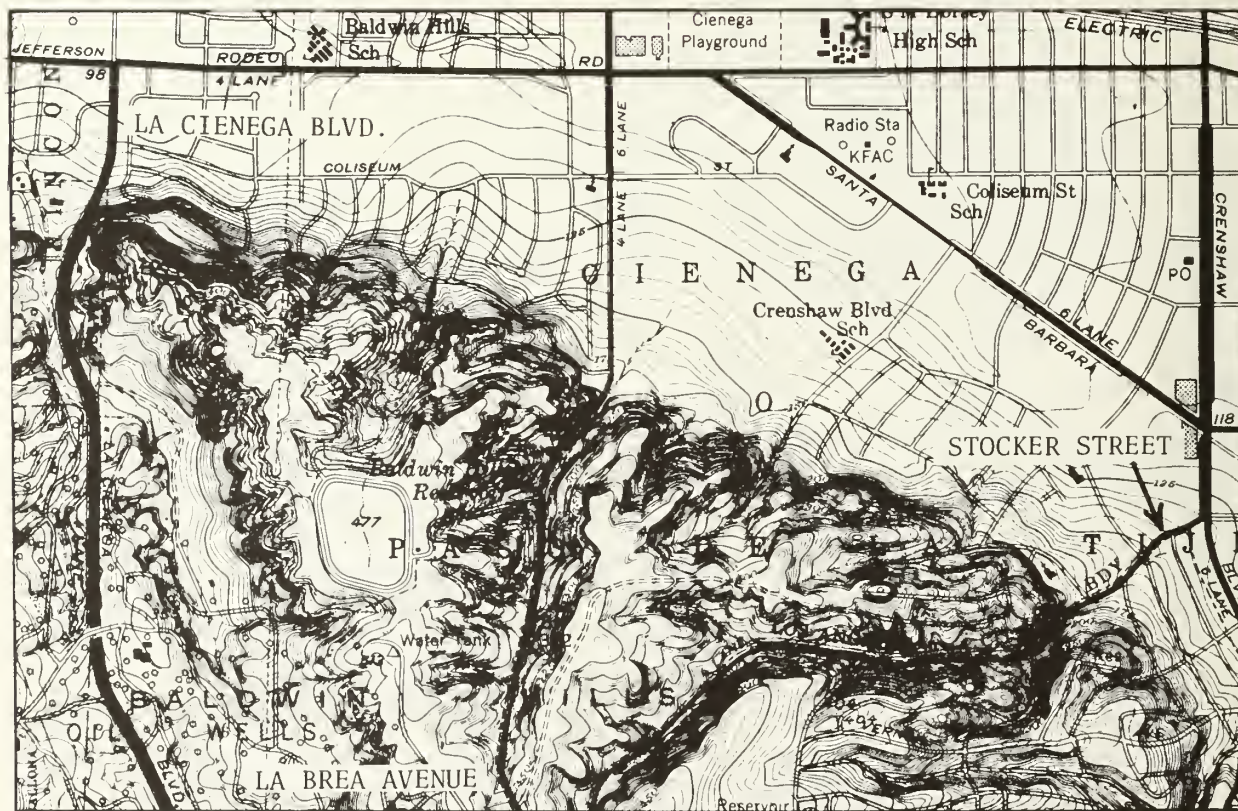
Figure 4. Steepness of the north flank and adjoining terrain of the Baldwin Hills is highlighted by the closely spaced 5-foot contours of a part of the U.S. Geological Survey 7½-minute Hollywood quadrangle (1953 edition). Failure of steep, modified slopes caused widespread damage in 1978.

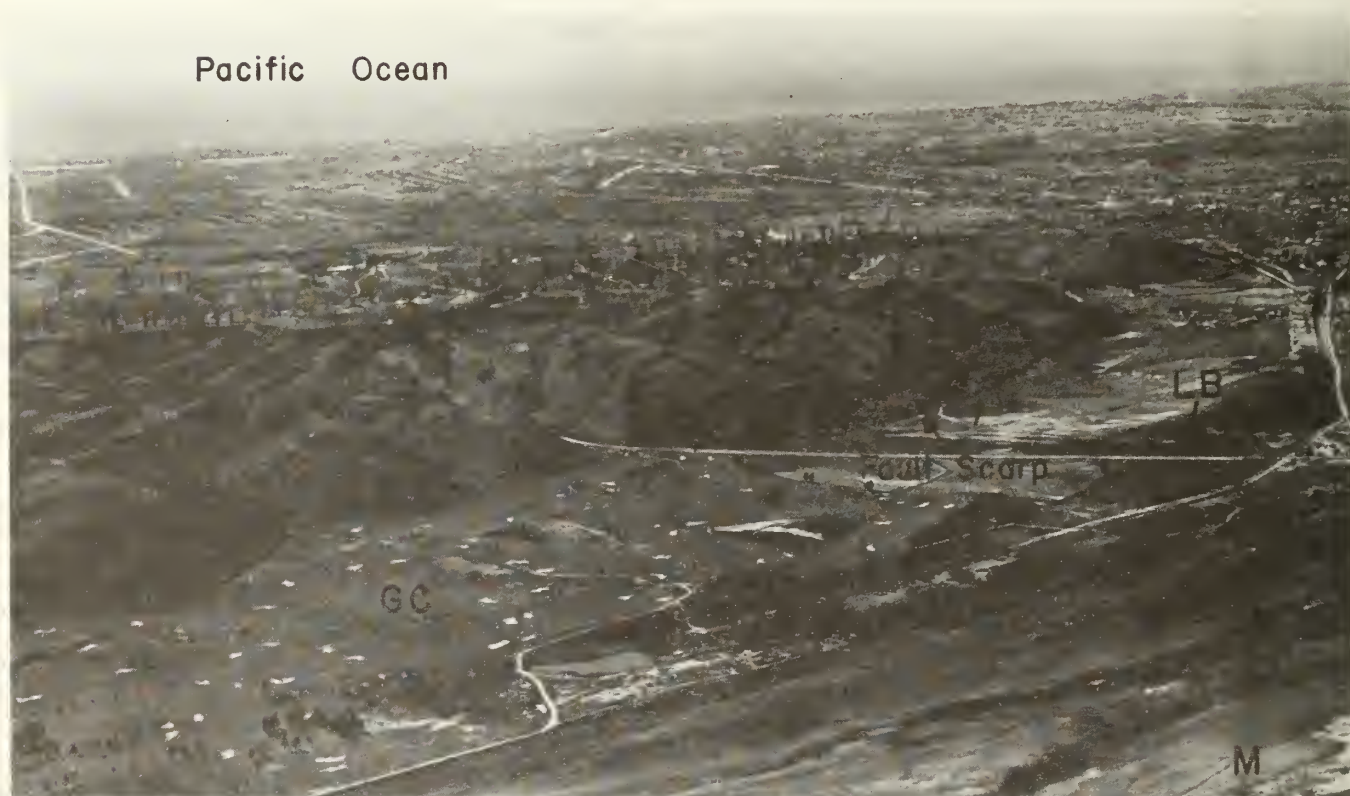
Photo 2. Aerial view west on February 25, 1936, shows steep escarpment along the north side of the Baldwin Hills which, at that time, were developed essentially only by the Inglewood oil field. Ancient bedrock landslide and possible ancient (questioned) bedrock landslides outlined on the photograph exemplify the slope instability of the natural terrain of the Baldwin Hills before it underwent residential development. Lower right hand corner of photograph shows a vestige of the morshy ground (M) that was once fairly widespread in the area north of the hills. (Additional symbols: LB, La Brea Avenue; SB, Santa Barbara Avenue, GC; golf course.) Photograph is from the Spence Collection, Department of Geography, University of California, Los Angeles.

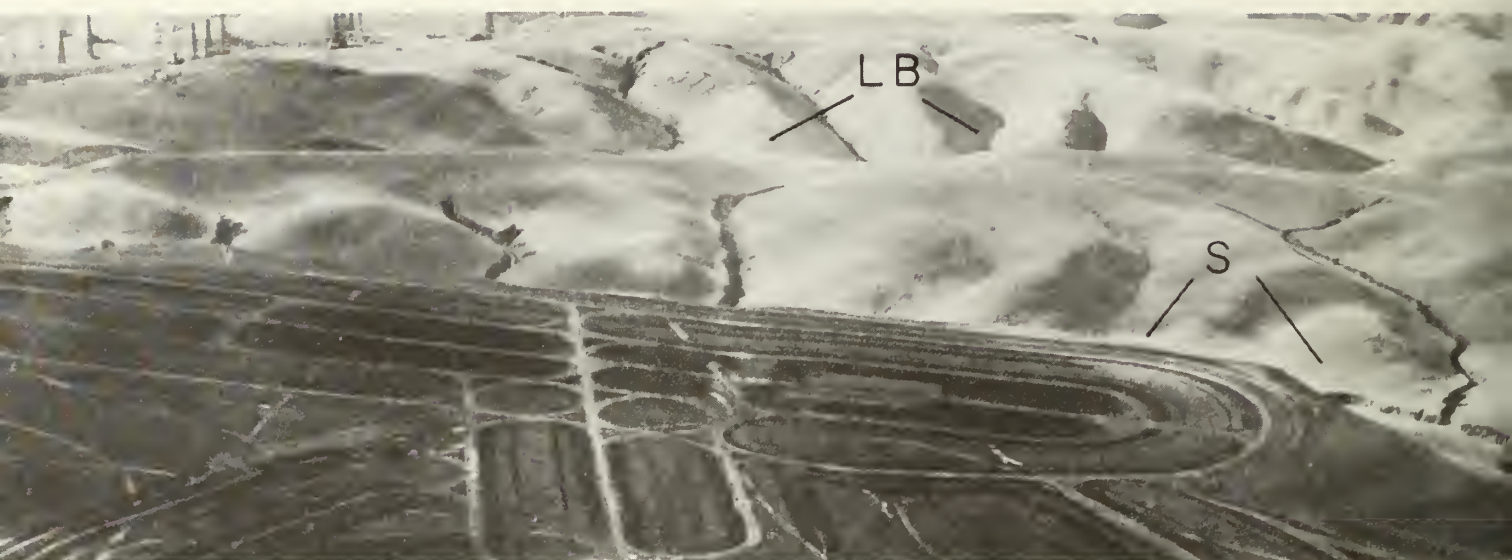
Photo 4. Aerial view westerly on February 9, 1932 shows site in preparation for athlete's village for 1932 Olympic games. The site is just east of the canyon (S) that now contains Stocker Street. The village site was later developed residentially as a part of View Park and Windsor Hills. Incised drainages occur in Stocker Street canyon and canyons to east of Stocker Street and west of the canyon (LB) that now contains Lo Breo Avenue. Incision of the drainages could have been the partial result of relatively recent tectonic uplift of the Baldwin Hills. Incision also could have been partially caused by the heavy rains of the winter of 1931-32 flushing colluvium out of the canyon bottoms. Photograph is from the Spence Collection, Department of Geography, University of California, Los Angeles.

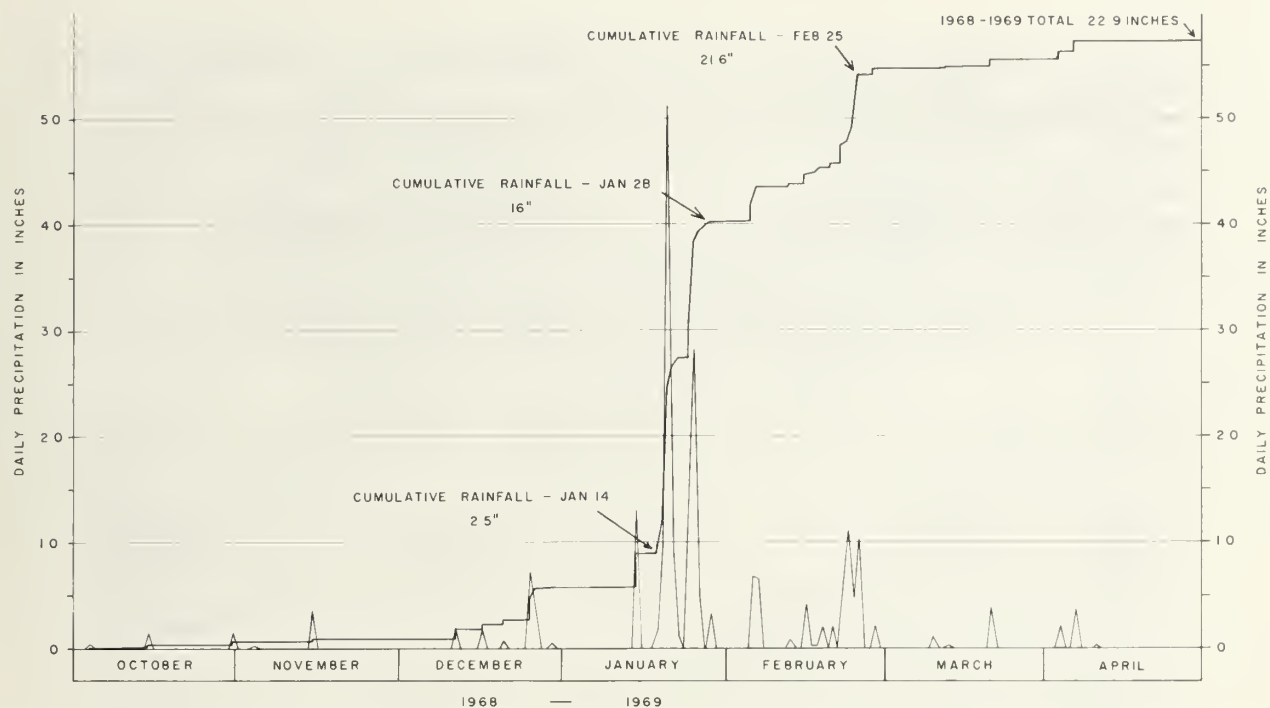
Figure 6a. Principal precipitation during 1968-69, at Inglewood fire station 116D, just south of the study area (latitude $33^{\circ} 57' 53''$ and longitude $118^{\circ} 21' 22''$; elevation 153 feet). Principal slope failures occurred in the Baldwin Hills during the intense rains of late January 1969, after the ground was saturated by rain earlier in the month.

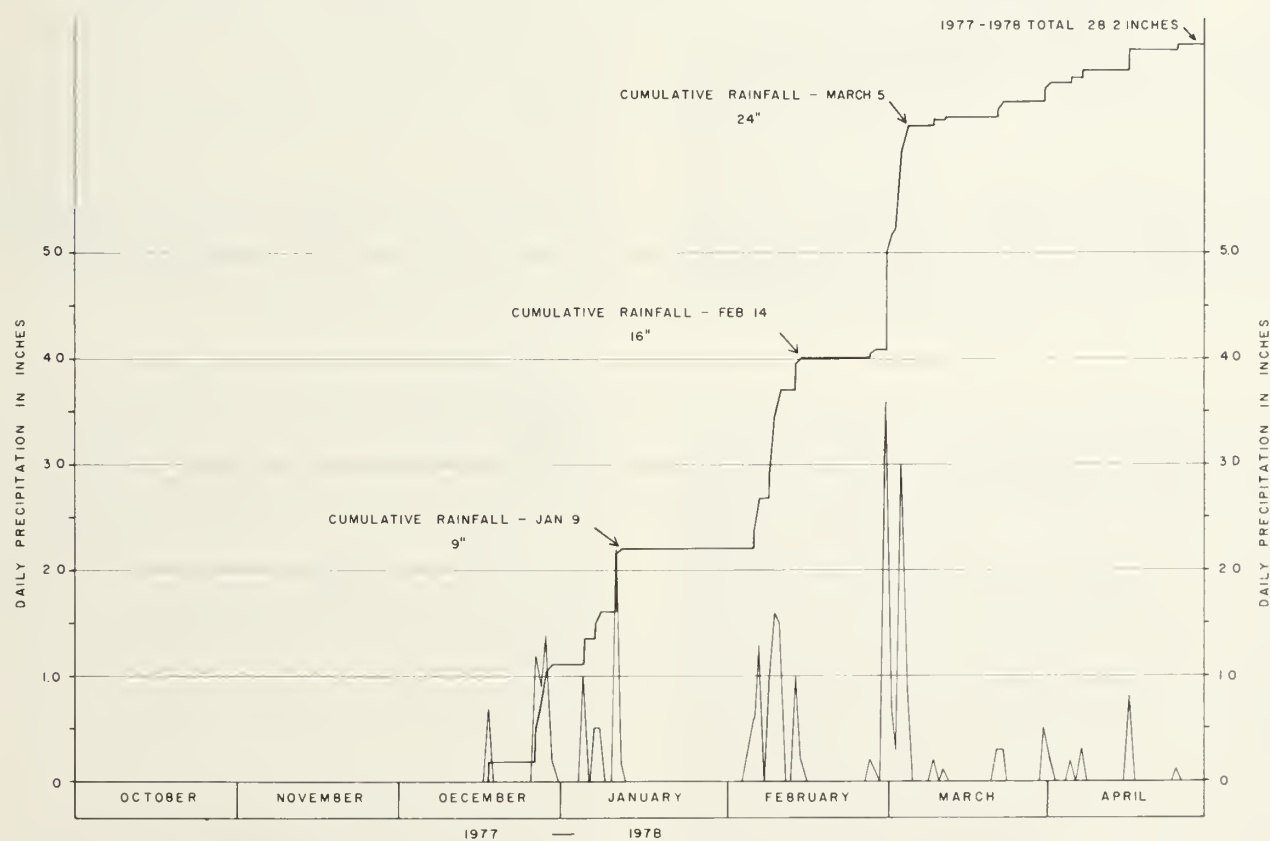
Figure 6b. Principal precipitation during 1977-78, at Inglewood fire station 116D. Principal slope failure in the Baldwin Hills occurred during the intense rains of late March 4-5, 1978, after earlier rains had saturated the ground.

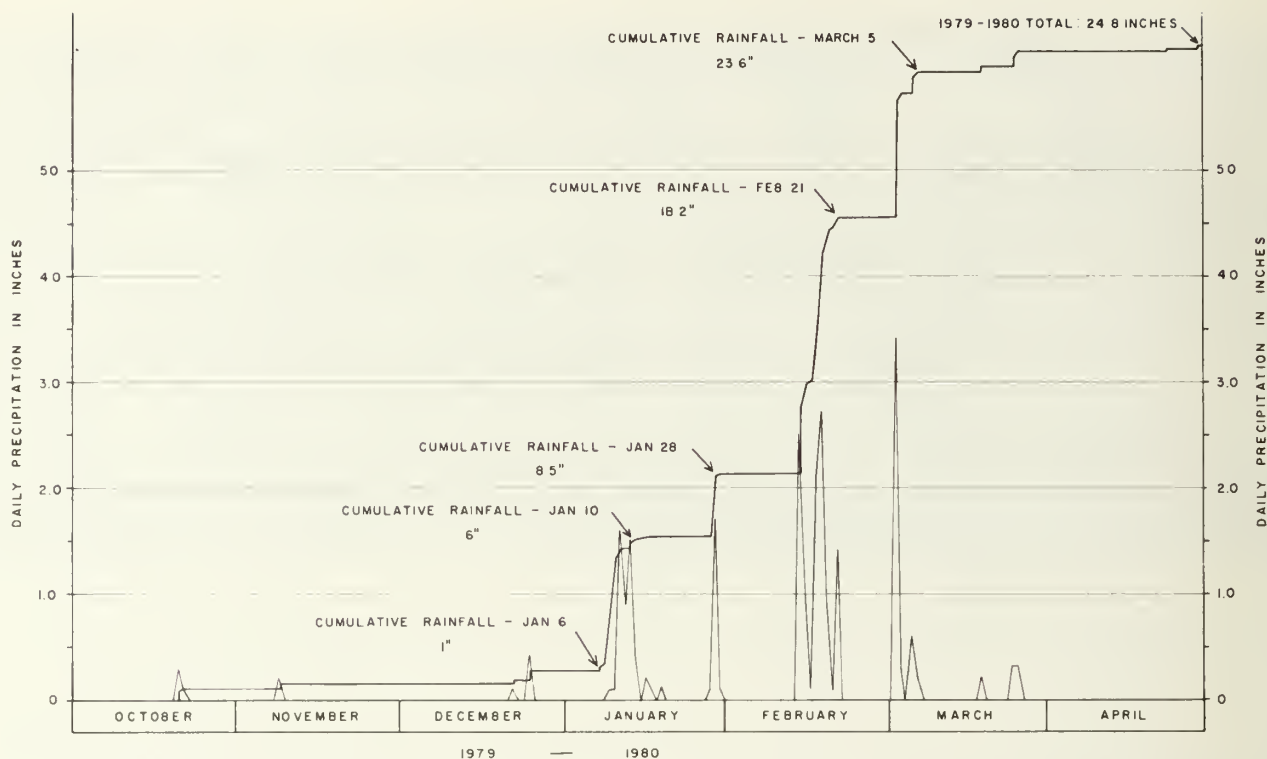
Figure 6c. Principal precipitation for 1979-1980 at Inglewood fire station 116D. Slope failures in the Baldwin Hills occurred during February and March 1980.

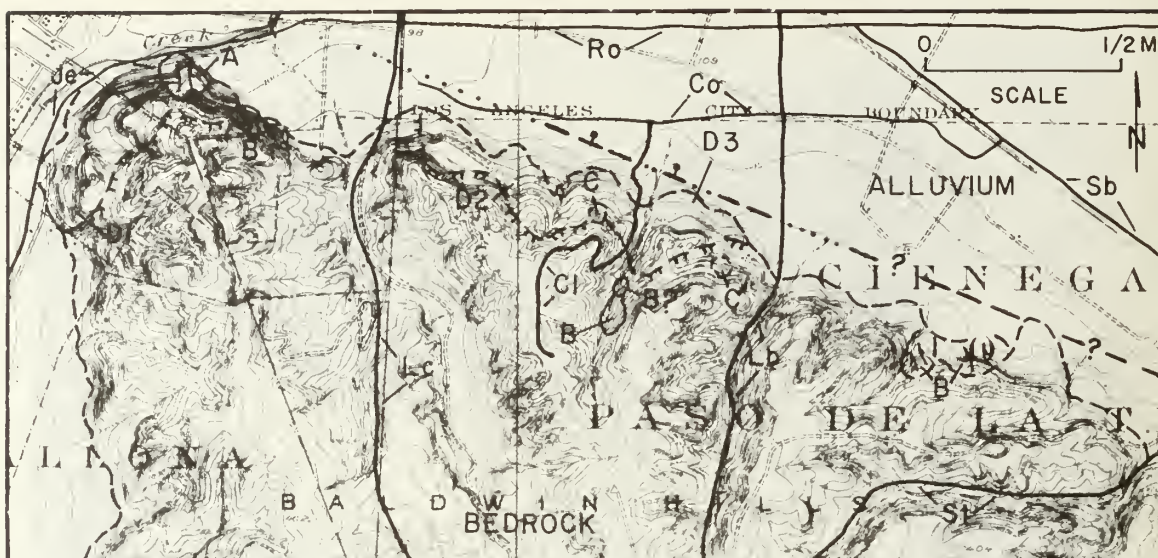
Figure 7a. Portion of U.S. Geological Survey Hollywood 6-minute quadrangle (1926 edition, contour interval 5 feet) showing undeveloped steep topography and types of ancient landslides and probable and possible ancient landslides derived from bedrock in the northern Baldwin Hills: A, well-identified (arrows show direction of sliding) (Photo 7); B, probable landslides, as identified on predevelopment aerial photographs (arrows show direction of sliding where appropriate) (Photos 3 and 7); C, possible landslides, as identified on pre-development aerial photographs; D, bedrock areas identified as possible landslides because of unusual topography depicted on this map or as shown on aerial photographs (D1, D2, and D3; Photos 2 and 8). Bolls on fault face in direction of opposite scarp in youthful alluvium, as shown on Photo 8. (Additional symbols: Co, Coliseum Street; Cl, Cloverdale Avenue; Je, Jefferson Boulevard, LB, Lo Breo Avenue; LC, Lo Cienega Boulevard, Ro, Rodeo Road; St, Stocker Street; SB, Sonto Borboro Avenue).

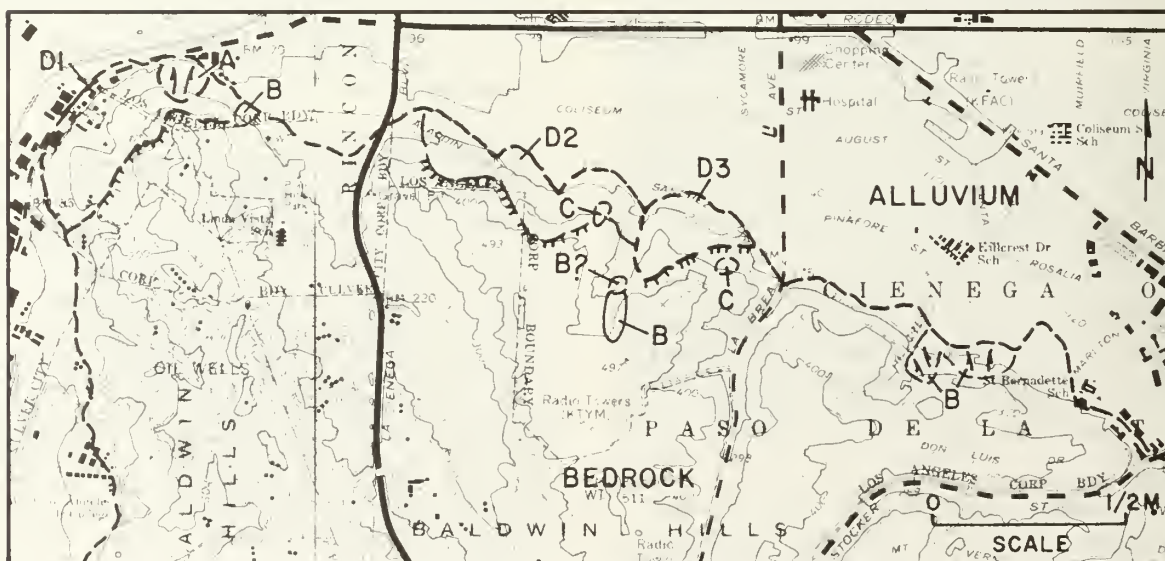
Figure 7b. Portions of adjoining Hollywood and Beverly Hills 7 1/2-minute quadrangles (1972 editions), showing developed northern Baldwin Hills and four types of bedrock landslides and probable and possible bedrock landslides: A, well-identified landslides; B, probable landslides; and C and D 1-3, possible landslides. (See Figure 7a for further explanation.)

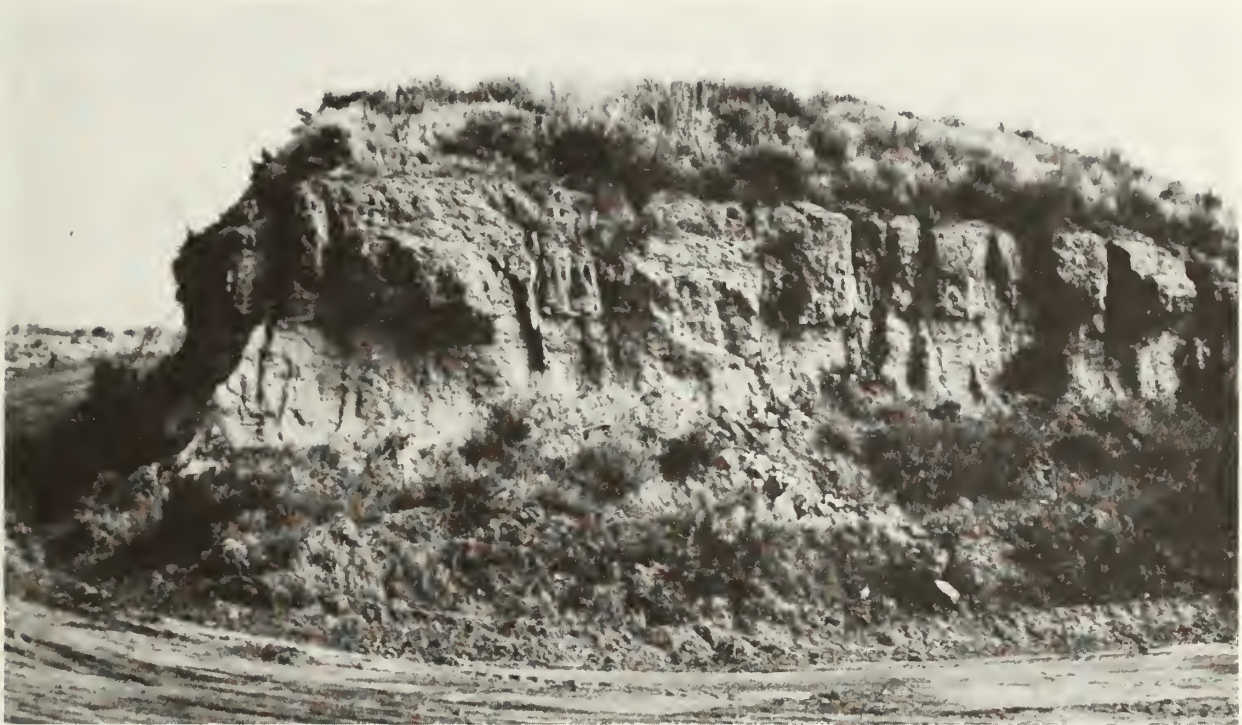
Phata 6. View shows Fax Hills relict paleasal (Qf) which caps ridges and terrace surfaces in the Baldwin Hills ond is easily recognized by its red-brown color. This material ranges locally somewhat in texture and firmness but, in general, consists of firmly clay-banded, paarly sarterd, pebbly to gravelly sand. It is the mast stable rock unit in the Baldwin Hills. The vertical fractures are clay-coated. Because it is generally impermeable, the unit canstitutes a hazard where percolation is required.

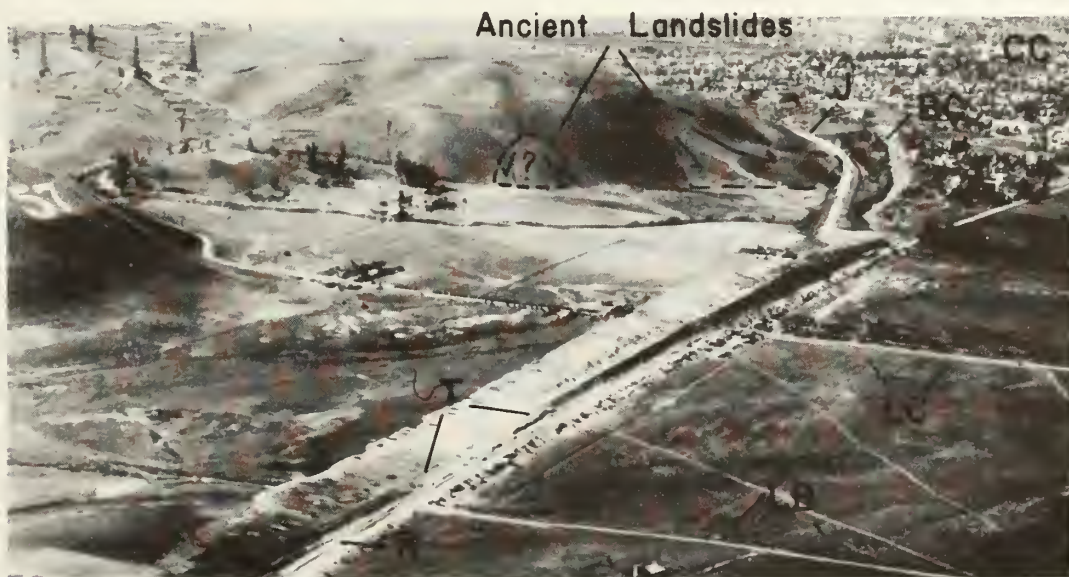
Photo 7. Aerial view south in 1936 at the northwestern edge of the Baldwin Hills shows ancient landslides that are mapped on Plate 1. The number "57" refers to an oil company apering in the area at that time. Trench (T) exposes a succession of Quaternary sediments described earlier by Tieje (1926). (Symbols designate sites or future sites of additional features as fallows: BC, Ballana Creek; CC, Culver City; J, Jefferson Baulevord; LB, La Brea Avenue; LC, La Cienega Baulevard; R, Radea Road.) Photograph is from the Spence Collection, Department of Geography, University of California, Los Angeles.

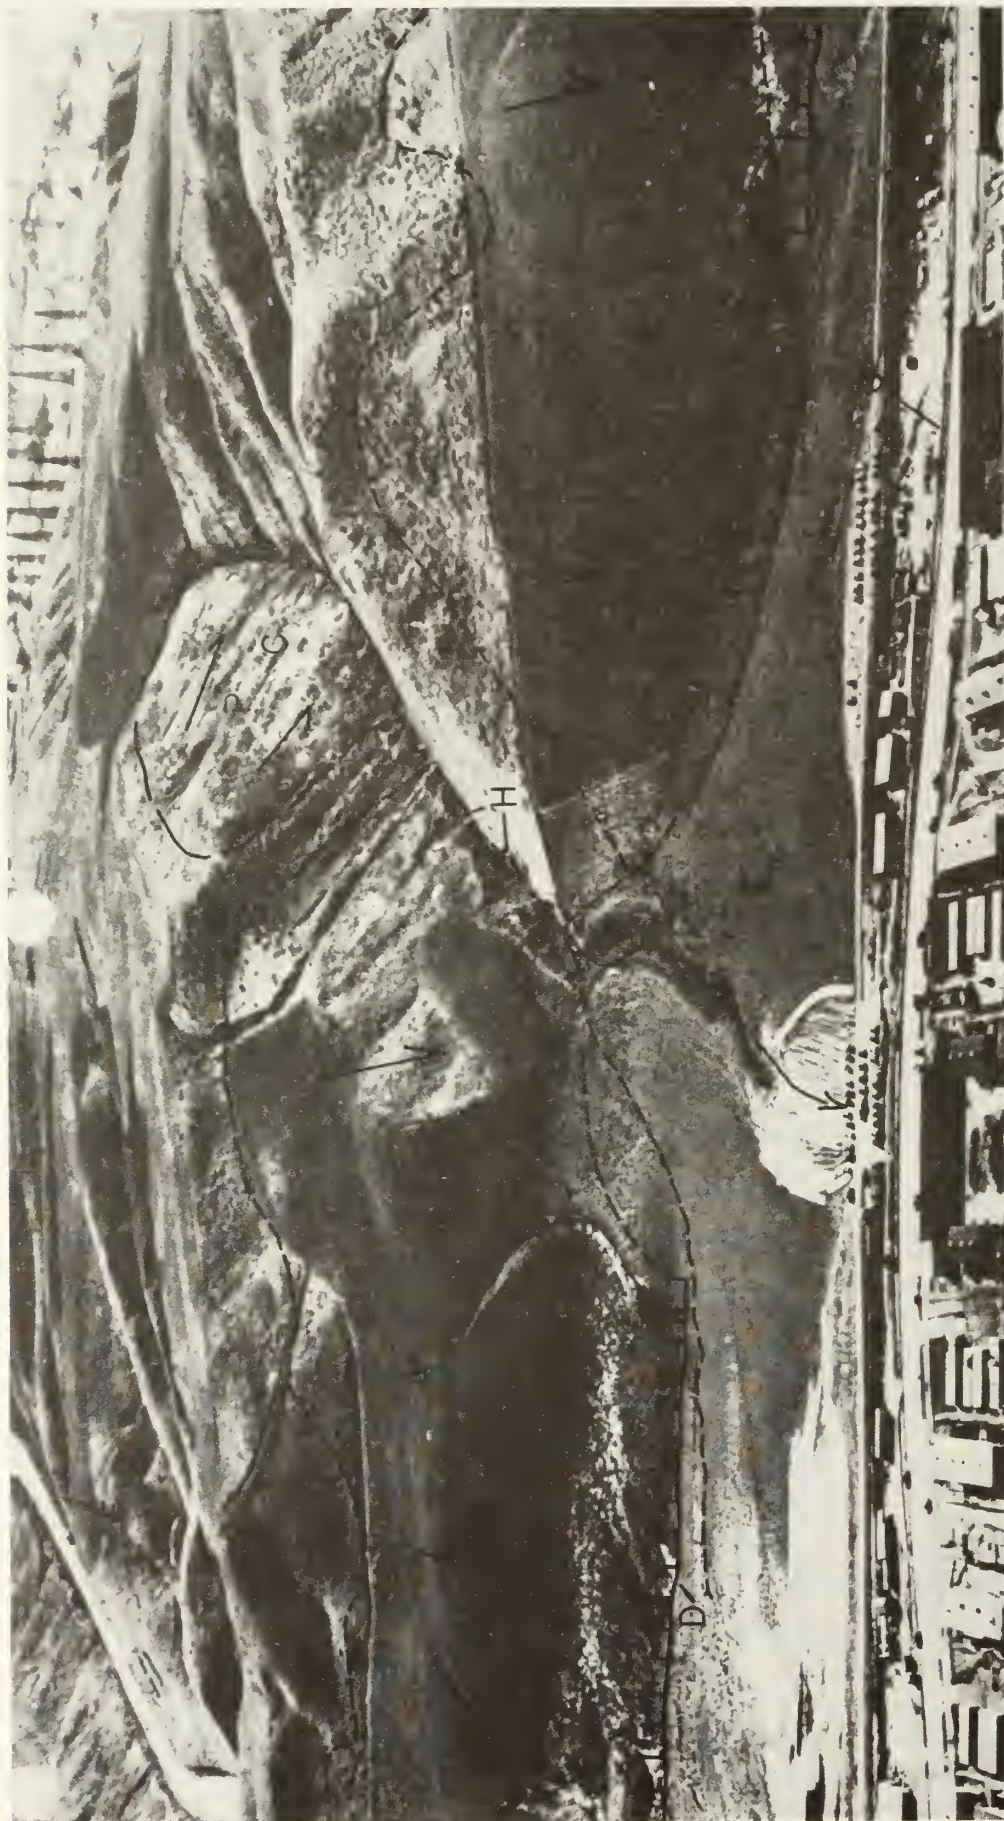
Photo 8. Aerial view south, probably in the early 1940's, shows essentially natural terrain in vicinity of the canyon in which Cloverdale Avenue was later constructed. Probable and possible landslides shown (A and B) are also depicted on Figures 7a and 7b, and landslide C is shown on Plate 1. Note that the apparent north-facing fault scarp (D) is very youthful, overlain only by the most recent alluvial fan deposits from the canyon; incision of drainage in fan shown with arrow (E) probably occurred since latest movement on fault. (Additional symbols: F, Lo Breo Avenue; G, Coliseum Avenue; H, site of future Cloverdale Avenue.) Photograph is from *History Division, Los Angeles County Museum of Natural History*.

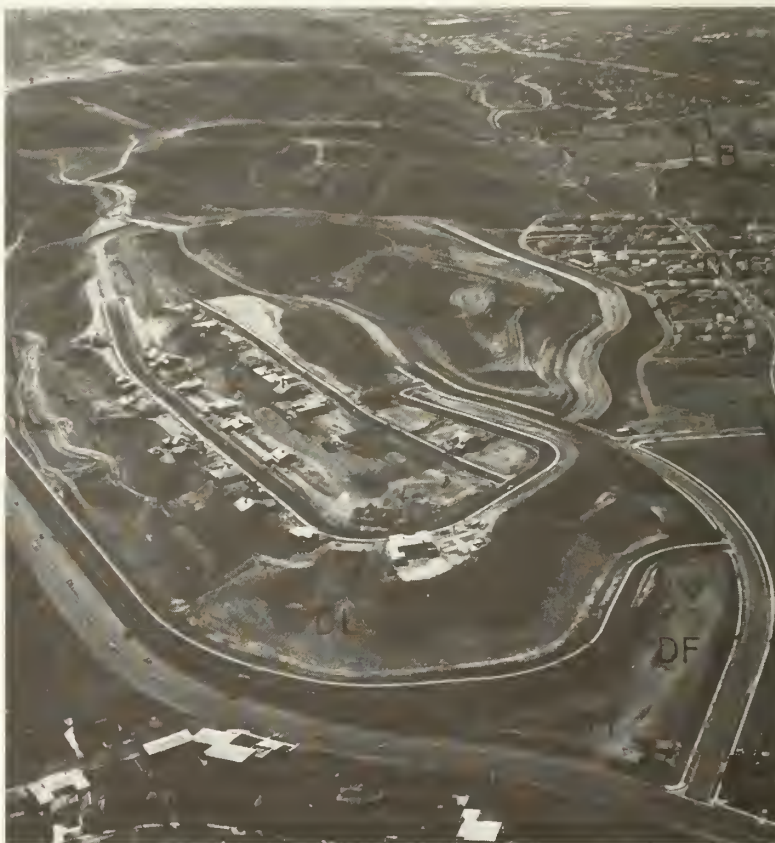
Photo 10. Aerial view to the west-northwest on June 2, 1951, shows grading and construction underway for single-family residences just west of the intersection of Stocker Street (S) and Don Felipe Drive (DF). The porticular cut and fill method of grading used in development resulted in many steep unstable slopes of the natural topography that were made even steeper, and thus, even more unstable. (Additional streets: DD, Don Dioble Drive; DL, Don Luis Drive; DT, Don Tomoso Drive; LB, Lo Brea Avenue.) Photograph is from the Spence Collection, Department of Geography, University of California, Los Angeles.

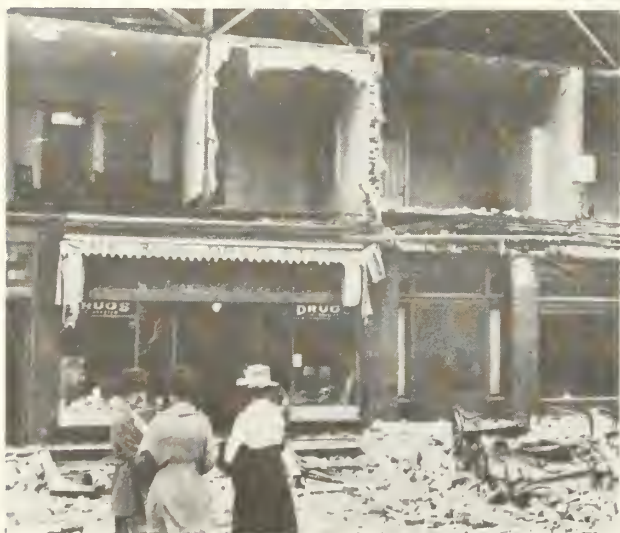
Photo 12. View of damage in Inglewood caused by the 1920 Inglewood earthquake. Photograph is from a report on the earthquake by Tober (1920).

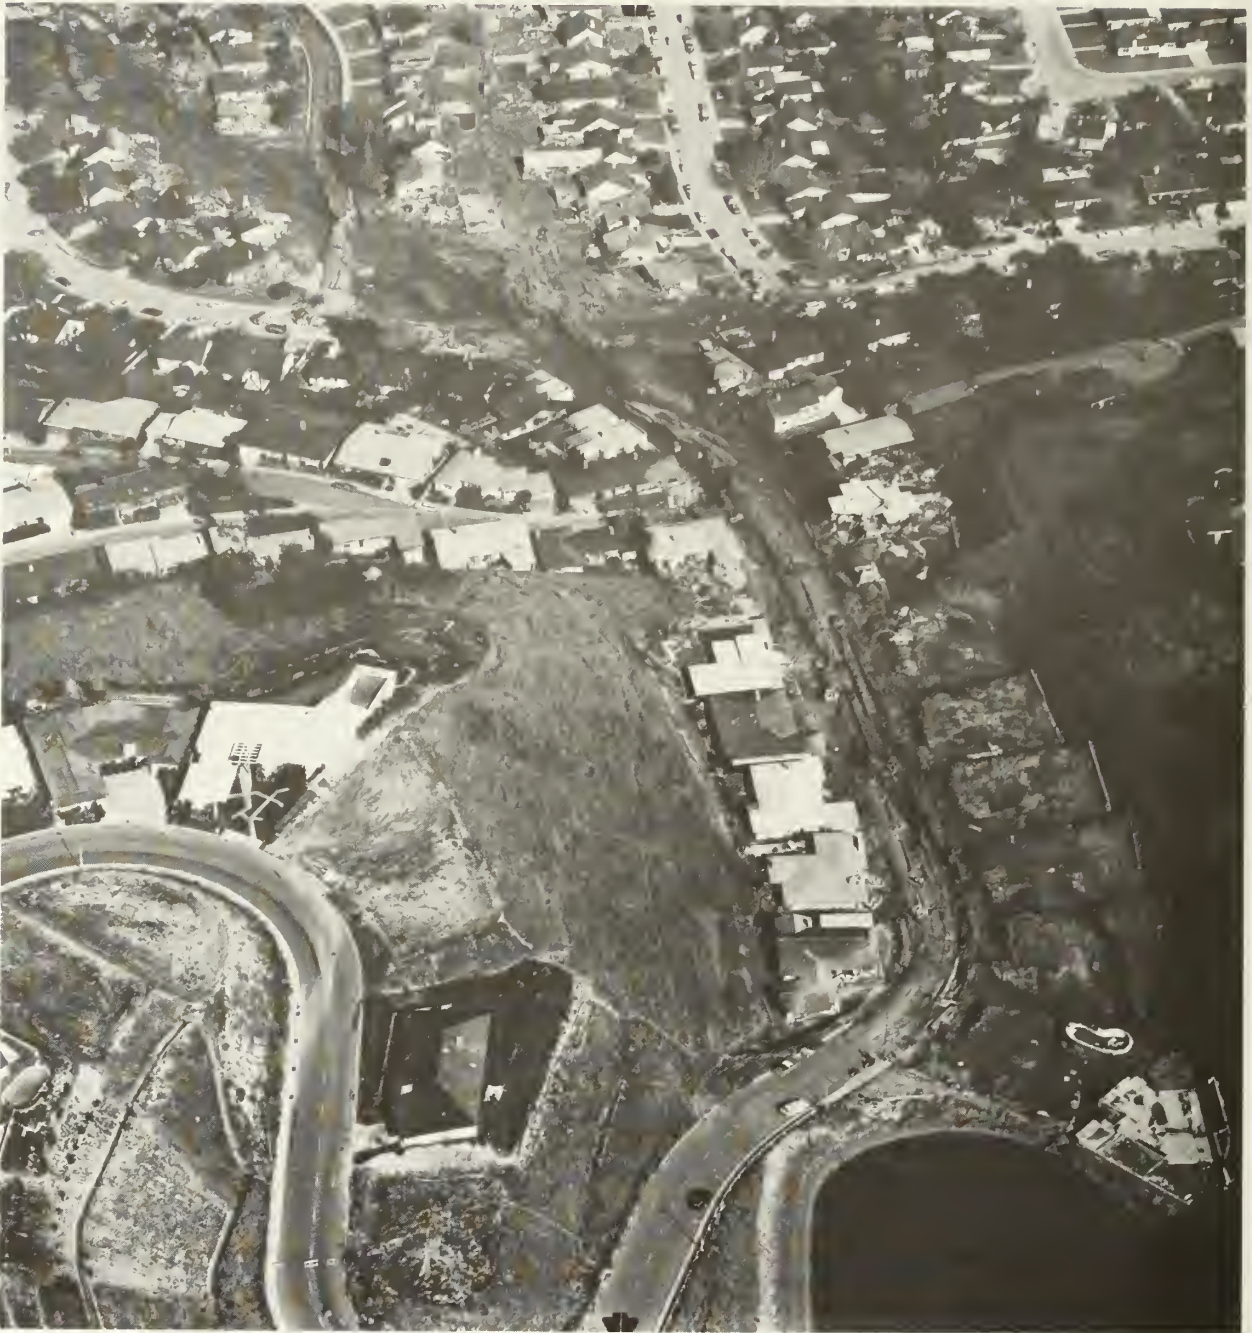
Photo 13. Aerial view north showing scene along Cloverdale Avenue after the flood on December 14, 1963, caused by rupturing of Baldwin Hills Reservoir Dam. The force of the water flowing down-canyon tore houses from the building pads shown vacant along the east side of the canyon. Houses were rebuilt on all but the more southern pads. The steep slopes behind the new houses, and houses on the west side of the street, yielded numerous damaging slope failures in 1978. (Localities 29-42, Sub-area 2, Plate 1 and Table 3b.) Photograph is from the Spence Collection, Department of Geography, University of California, Los Angeles.

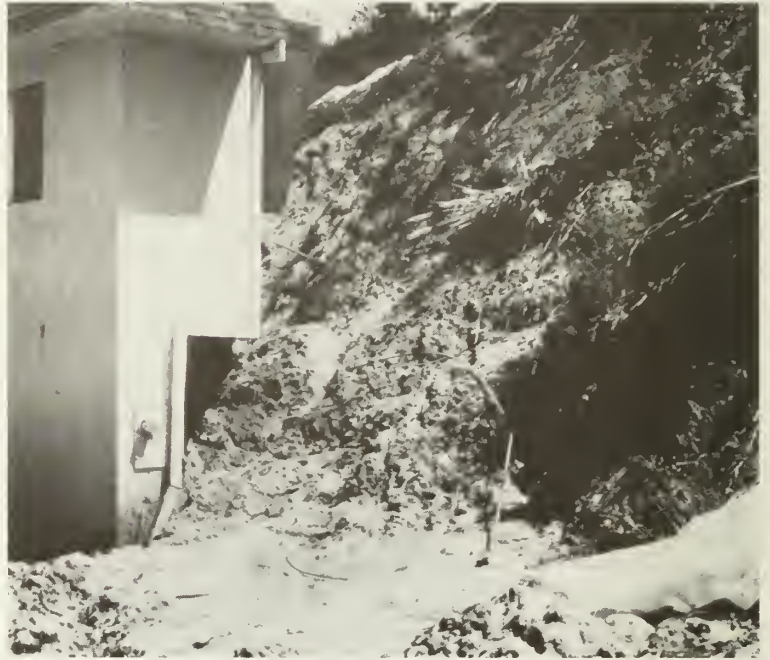
Photo 29. View east shows south edge of house in Photo 28 after the adjoining slope was cleaned off and repaired after the 1978 rains. Note that erosion caused by the 1980 rains cut well into the bared bedrock slope. View also shows an apparent angular discordance between beds of the Baldwin Hills sandy gravel (Qb, Plate 1) (parallel to and above the fence top) and underlying beds of the Culver sand (Qc).

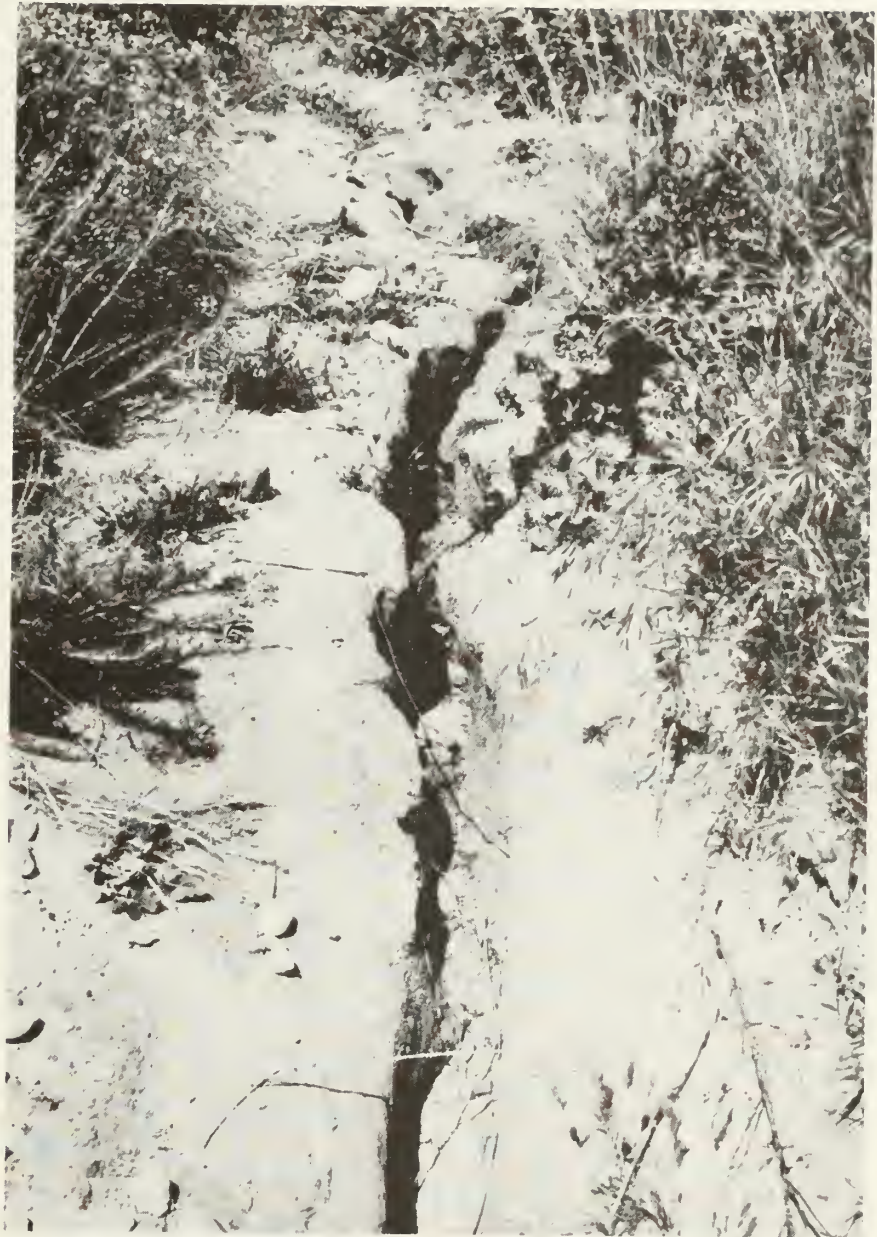
Photo 31. Erosion beginning to gully part of the same trail shown in Photo 30. Development of the gully has caused the trail to be abandoned. A new route would create similar results.

Dirt bike trails at the vacant north end of the Inglewood oil field area illustrate the consequences of destroying the continuity of the vegetation on natural slopes (Locality 92) (Photos 30 and 31). These trails, where gullied, should be filled in and replanted. The oil field area offers an opportunity to experiment with drought resistant plants as agents of slope protection. Some such plants are already well established in the area: *Chrysanthemum frutescens* (marguerite or Paris daisy), for example, an attractive perennial.

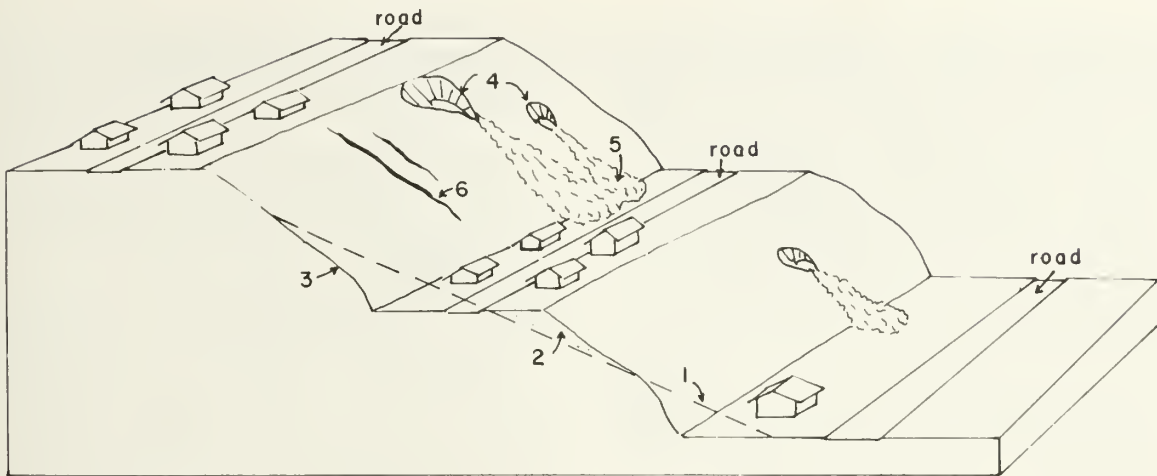
Figure 13. Typical slope resulting from grading during tract development in the 1950 s in the Baldwin Hills area. Natural, predevelopment slope (1) was steepened by fill placement at top (2) and cutting at base (3). Drainage benches were generally not provided. Cutting of natural slope commonly exposed loose, poorly indurated (poorly hardened) sandy bedrock. Fill may not have been adequately compacted and provided with subdrain devices. Slope failures common in such slopes are soil slips and slumps (4), debris flows (5), and erosion rills and gullies (6). (Not drawn to scale.)

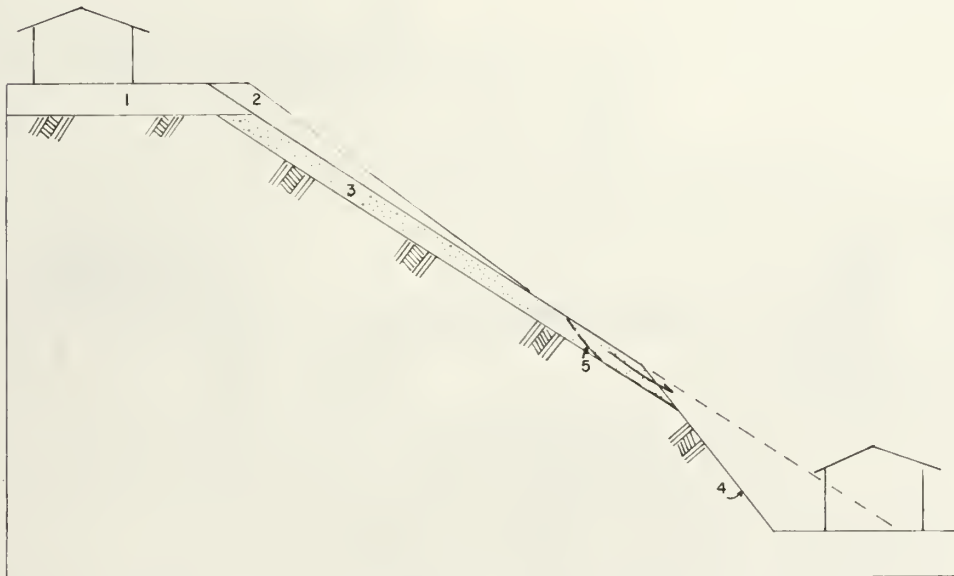
No slope failures were reported in 1978 and 1980. The relatively few slope failures reported to have occurred in 1969 consisted of shallow soil slips in both fill and cut slopes. Settlement and wedge-failure (Figure 14) of fill reported to have occurred in 1968 resulted in damage to the rear side of the house at 4260 Don Mariano Drive (see Locality 70). This settlement indicates that the fill apparently was not properly compacted during development. (Locality 70)

Figure 14. Diagrammatic cross section illustrating slope instability conditions that exist in residential areas of parts of the Baldwin Hills: (1) unstable wedge of the right corner of the fill placed during grading may fail due to gravitational movement if not properly benched or retained; (2) fill dumped over the top of slope during grading operation and not compacted adds to the unstable conditions; (3) slope mantle of soil, colluvium, and weathered bedrock is vulnerable to sliding; (4) cut at the toe of the slope made during tract development makes the unsupported slope mantle material above the cut vulnerable to creep, shallow slumps, and soil slips (5). Material in slips and slumps can slide or flow to base of slope and cause serious damage. (Not drawn to scale.)

silt or clay, which are compacted to at least 90% or better of maximum dry density. In order to be effectively emplaced, the fill should be keyed and benched into firm bedrock. Subdrains are necessary behind many engineered fills in order to prevent buildup during rainy seasons of hydrostatic pressure resulting from water perched in the fill and/or underlying bedrock.

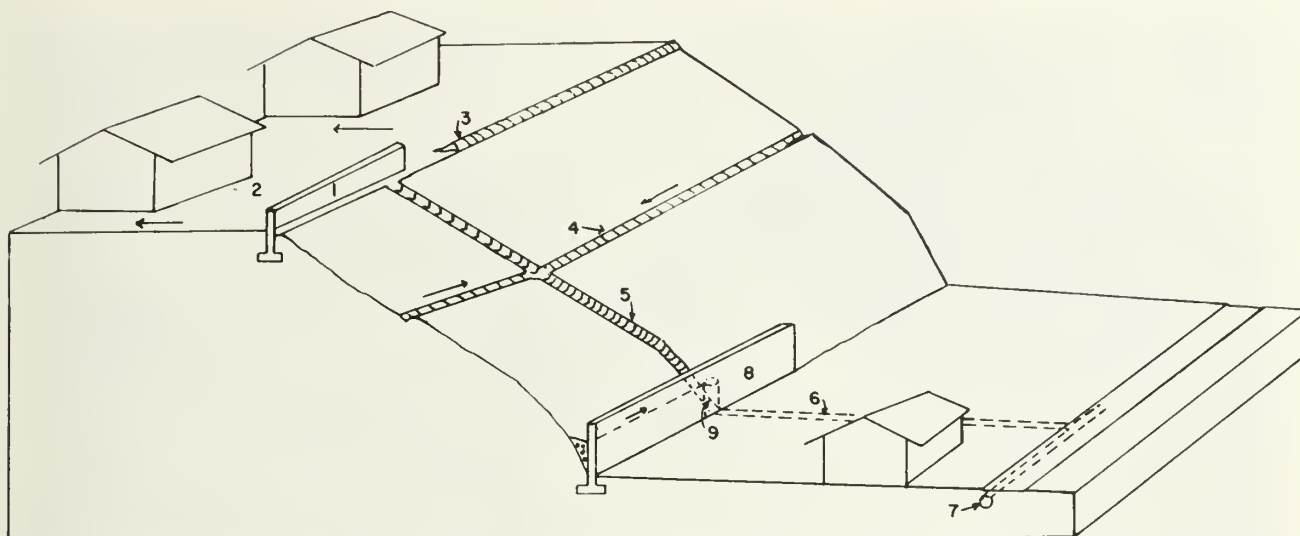
Figure 15. Diagram illustrating measures that can be utilized to alleviate slope instability in the study area: retaining wall (1) may be constructed to protect the property from lateral movement of fill wedge; (2) building pad can be regraded and backyard drainage diverted to street (arrow indicates correct direction of surface drainage); a berm (3) can be constructed at top of slope to prevent water from draining down slope; a bench drain (4) and slope drain (5) can be constructed on the slope to intercept and collect rain water falling directly on the slope surface and to discharge it through an underground pipe (6) into the storm drain along the street (7). A slough wall (8) can be constructed at the toe of the slope to intercept debris flows. Compacted fill should be placed behind the wall and graded so that flow (see arrow) is diverted into a drain-pipe (9) that feeds the outlet pipe (6). (Not drawn to scale.)

Surface drainage devices on slopes consist of terraced drainage benches and down-slope drains, as illustrated in Figure 15. When the height of a slope is great, drainage benches, terraces, or swales should be established on the slope at vertical height intervals specified in the applicable grading code or as determined by a soils engineer. Water diverted along such benches is collected into a downslope drain, possibly also using sub-surface (sub-) drains, and eventually discharged into the street or into storm drains. To prevent bench drains and slope drains from being eroded, a gunite or asphalt surface is usually placed on them.

In addition to drainage devices on slopes, precautionary measures should be taken to control drainage for building pads on the tops of slopes. Proper surface drainage control of building pads ("positive pad drainage") is essential in maintaining the integrity of underlying or adjoining fills. No rain water should be allowed to pond on pads; it should drain freely to existing streets and drains, using a combination of proper grading and surface or near-surface drain systems. For a backyard that does not have a retaining wall provided with freeboard to stop overflow, a diversion berm should be maintained along the top of the slope so that water will not flow over the edge (Figure 15).

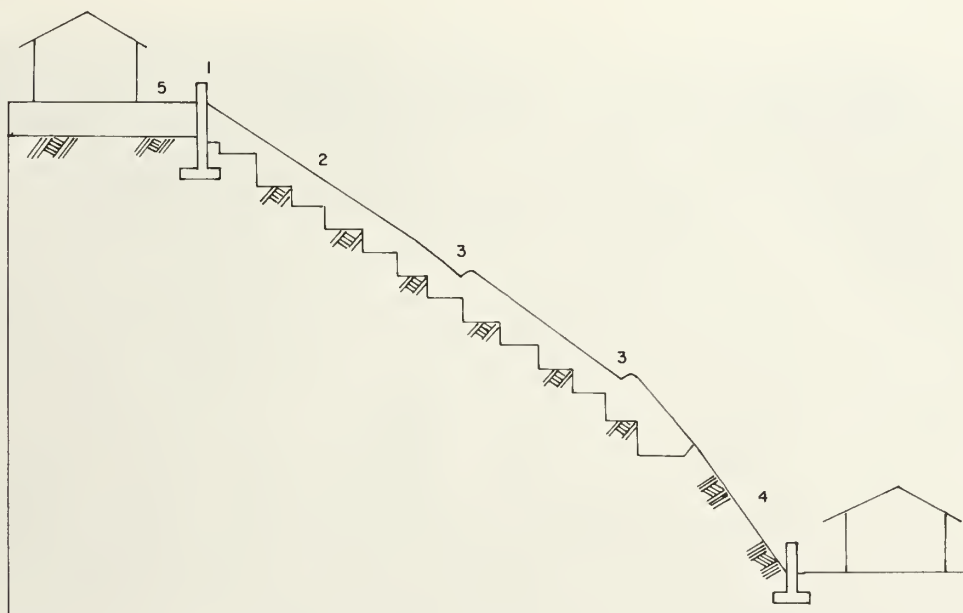
Figure 16. Diagrammatic cross section illustrating alternative remedial measures utilizing engineered fill to stabilize slopes in residential areas of the Baldwin Hills: (1) construction of properly designed retaining wall and drainage devices (such as granular backfill and drain pipe behind the wall and weep holes in the wall); (2) loose soil and slide debris are removed, stabilization fill should then be properly keyed and benched into firm bedrock as shown, and adequate subdrains provided. For steep slopes, soil-cement fill may be desirable. (3) Gunite or concrete bench drains that divert water to discharge outlet are constructed. (4) Retaining or slough wall, with adequate freeboard and drainage devices, may be required at the toe of a cut slope, particularly if the slope material is poorly consolidated. (5) Surface water flow on building pad should be directed away from the slope to the street, and water should not be allowed to flow from the pad down the slope. (Not drawn to scale.)

Application of engineered fill. When slopes have been damaged by surficial landsliding, the material that slid and adjacent, unslid but weakened surficial material can be removed down to bedrock and replaced with compacted, engineered fill (Figure 16, item 2; Photos 34 and 35). This fill should be composed of granular materials, with a reasonable amount of binder such as

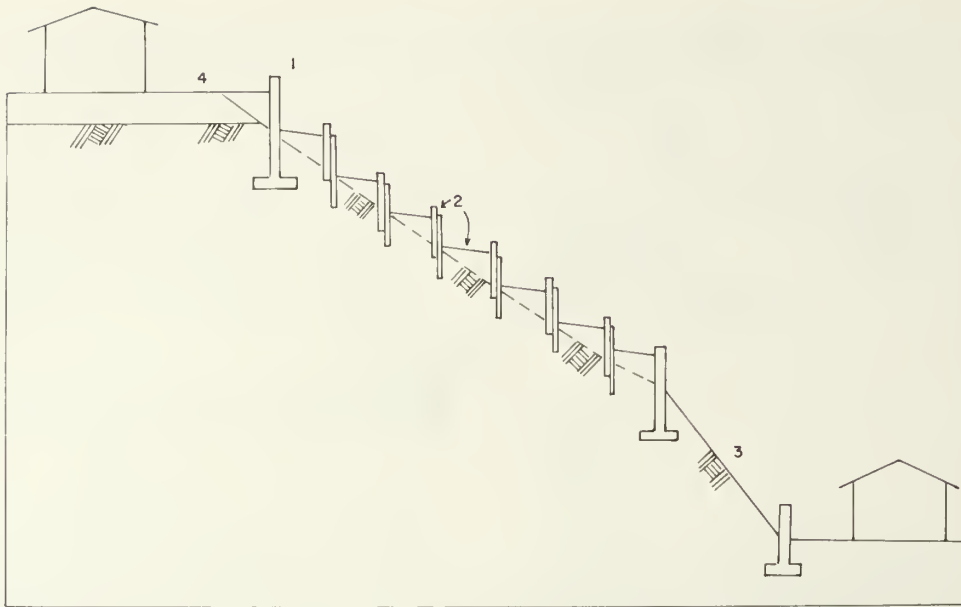
Figure 17. Diagrammatic cross section illustrating alternative remedial measures utilizing a revetment system to stabilize slopes in residential areas of the Baldwin Hills: (1) Construction of retaining wall—foundation of retaining wall should be properly designed and placed in firm bedrock (coissons or piles are frequently used). Permeable materials and proper drainage devices and relatively impervious surface blanket should be placed behind retaining wall to reduce hydrostatic pressure. (2) Retention structures—these generally consist of vertical pipes and boards. Pipes are driven into competent bedrock; back fill placed behind boards should be compacted and provided with proper surface drainage devices and proper slope vegetation cover. (3) Cut-slope should be properly planted and stabilized by retaining structures which should have adequate freeboard and proper surface drainage device to prevent water/mud flow damage to property. (4) Surface water flow on the building pad should be directed away from the slope to the street, and water should not be allowed to flow from the pad down the slope. (Not drawn to scale.)

Construction of revetment systems. A revetment system is generally a less effective but also a less costly method of slope stabilization which is generally applied as a temporary repair measure for damaged slopes (item 2 on Figures 15 and 17). Damaged slopes can be superficially repaired and stabilized with many types of revetment structures, such as board and pipe structures (batter boards) (Photos 38 and 39), railroad ties, poured-concrete walls, concrete-block walls, and other landscape devices. Figure 17 illustrates the method commonly used. For board and pipe systems, pipes are driven vertically into firm material, generally bedrock, to a depth sufficient to anchor them. Railroad ties or redwood planks are then placed so that they are supported by the pipes. Suitable materials are then backfilled against the planks and compacted to at least 90% of maximum

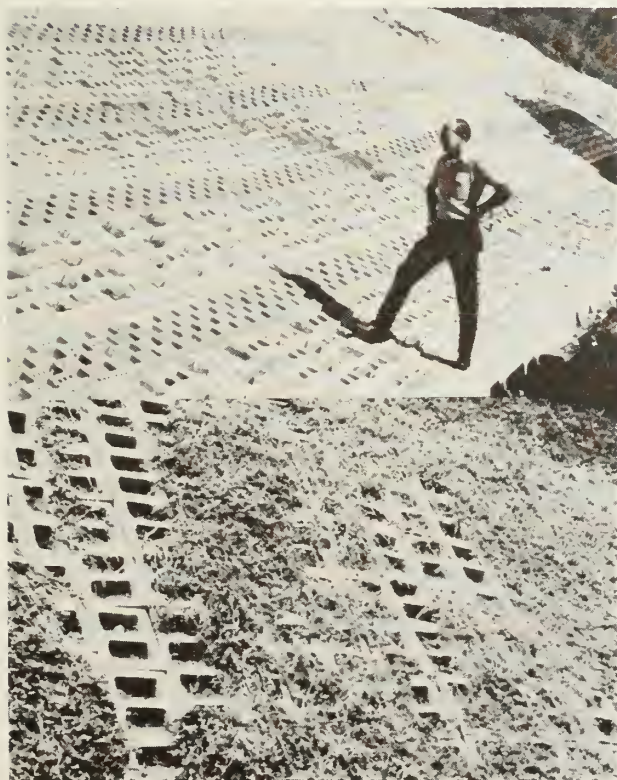
Photo 37. Illustration of use of building blocks for slope protection. Lower view illustrates how vegetation fills in among blocks, making an attractive slope. Locality is not in the Baldwin Hills. *Photograph courtesy of County of Los Angeles.*

In addition to gunite covers, building blocks can also be utilized to prevent erosion. The utilization of building blocks can be attractive because the holes in the blocks allow vegetational growth on the slope (Photo 37).
